## **Sika Technologies and Solutions for Waste Water Treatment Plants**

# Sika Waste Water Treatment Plant Solutions Contribute to a Sustainable Future

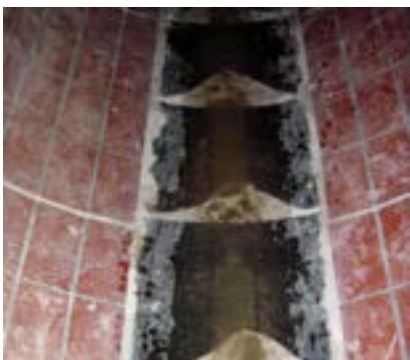
**1 Damages at the bottom:**  
Heavy abrasion and erosion of the concrete and prefabricated elements are often found at the bottom of the sewers.  
In general rules, these elements shall be replaced and reassembled properly by gluing them in place with an epoxy adhesive.

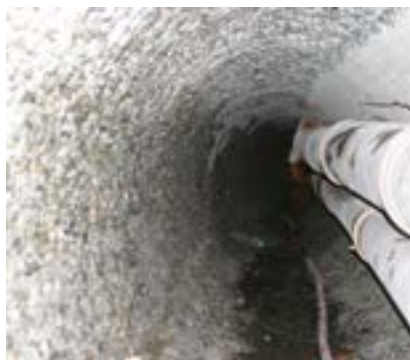
**3 Full degradation of the concrete surface:**  
The resistance of tamped concrete against a strong water current is generally not enough and often it is found the full surface of the concrete is eroded. It is recommended in these zones to proceed with a full resurfacing.

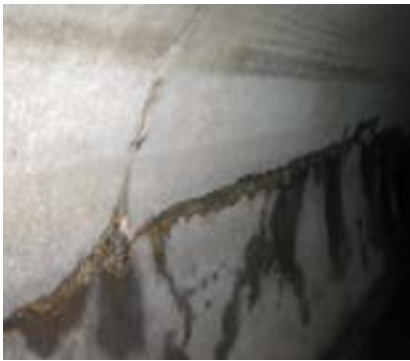
**4 Cracks with water leaks:**  
Due to shrinkage or settlements, concrete in sewers often crack. These cracks need to be filled in order to prevent leakage of pollutant to surrounding ground water. It is often necessary to use expanding materials to fill these cracks.

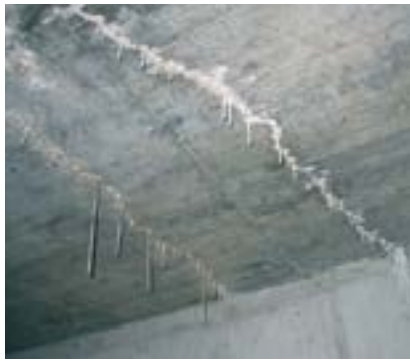
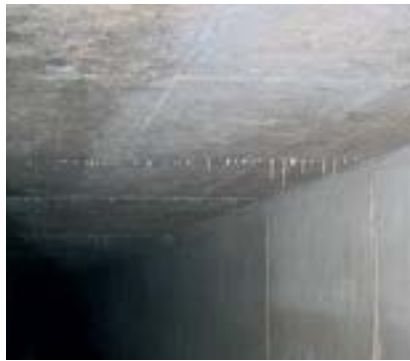
**5 Damages at the crown:**  
Exposed tamped concrete surfaces show very low resistance against carbonation and the aggressive substances contained in the waste water. Therefore, these surfaces can be protected using **EpoCem**® technologies

which are extremely resistant and watertight against urban waste water.  
At the crown area, the structure can be protected against condensation water using a hydrophobic impregnation.

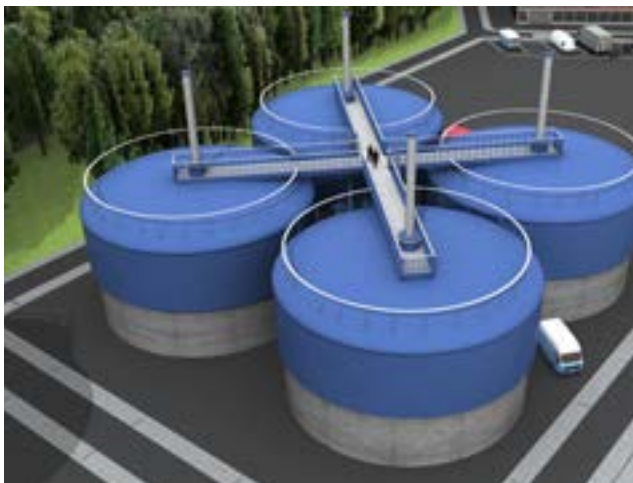
Gasometers

- Steel corrosion
- Untight joints
- Sulfuric acid damages

- Steel corrosion:  
**Sika® Icosit® 6630 System**  
or **SikaCor® EG System**
- Steel joint:  
**Sikaflex® TS Plus**
- Sulfuric acid attack:  
**Sika® Permacor® 3326 EG H**  
or **Sikalastic®-844 XT**

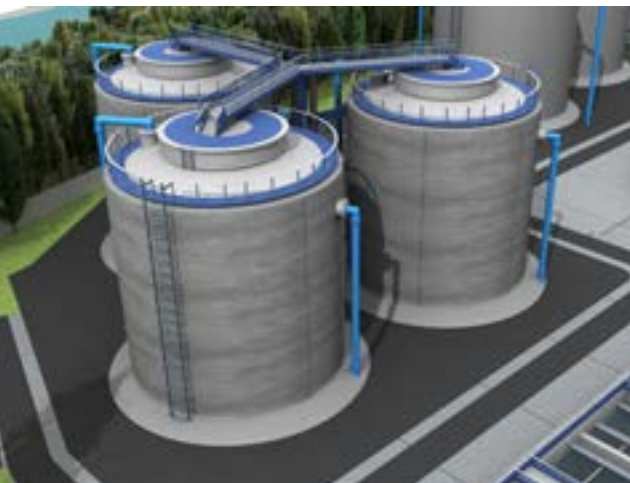
Digestion Tanks

- Concrete damage due to sulfuric acid
- Leakage due to damaged waterproofing
- Cracks due to thermal expansion or shrinkage

- Sulfuric acid attack and waterproofing:  
**Sika® Permacor® 3326 EG H**  
or **Sikalastic®-844 XT**
- Cracks:  
**Sikadur-Combiflex® SG**
- Chemical resistant joint:  
**Sikaflex® Pro-3**
